## **RYE A, c. 1500**

*Austin Siess*

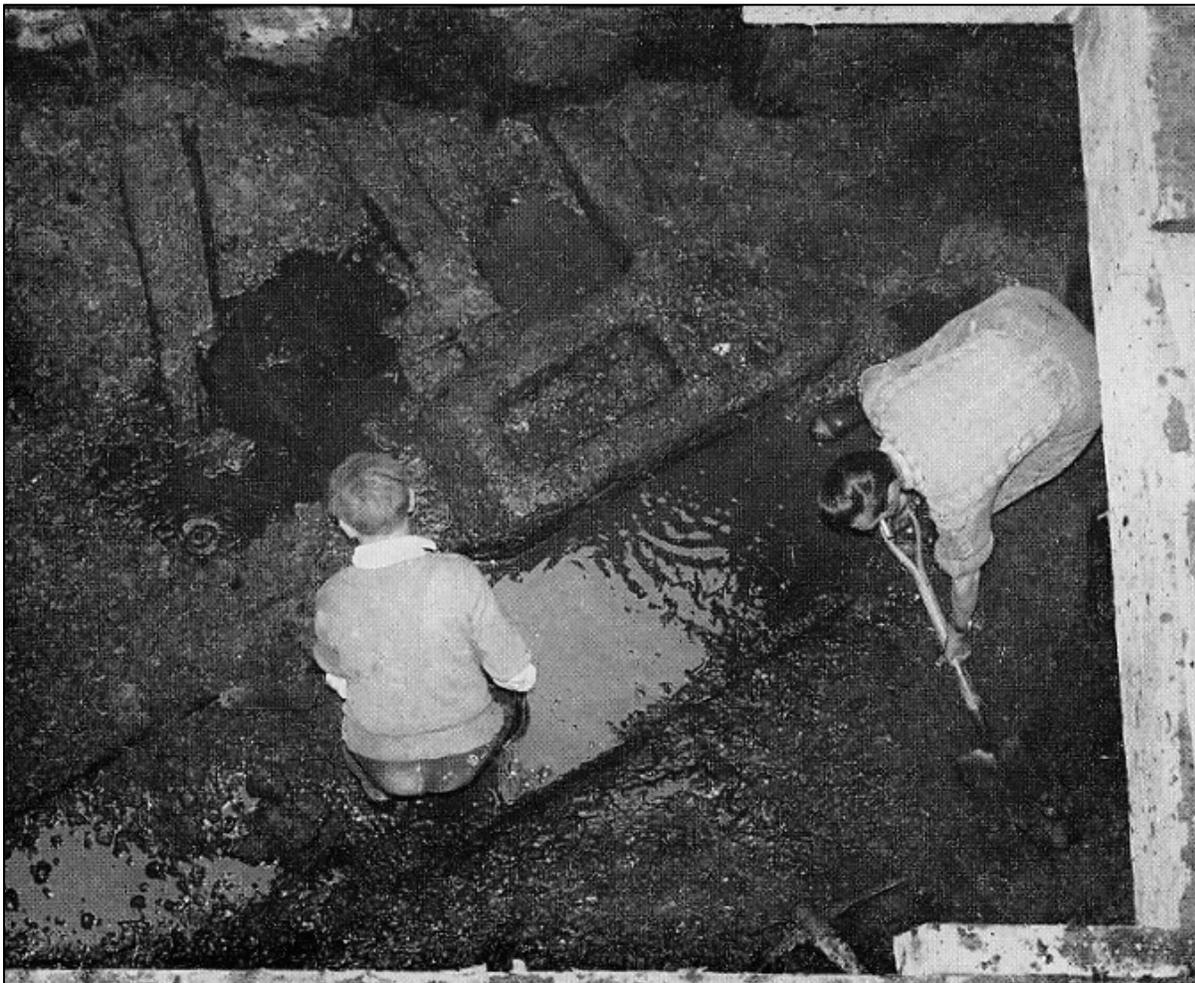
*Figure 1. Picture of the site (Lovegrove 1964).*
